Kaercher Creek Park

**Kaercher Creek Park
Hazardous Contamination Remediation
PFBC & Berks County
Proposed Work Plan**

FINAL TRIP REPORT

KAERCHER CREEK PARK REMOVAL ASSESSMENT AND EXTENT OF CONTAMINATION INVESTIGATION KAERCHER CREEK PARK – LAKE SITE WINDSOR TOWNSHIP, BERKS COUNTY, PENNSYLVANIA

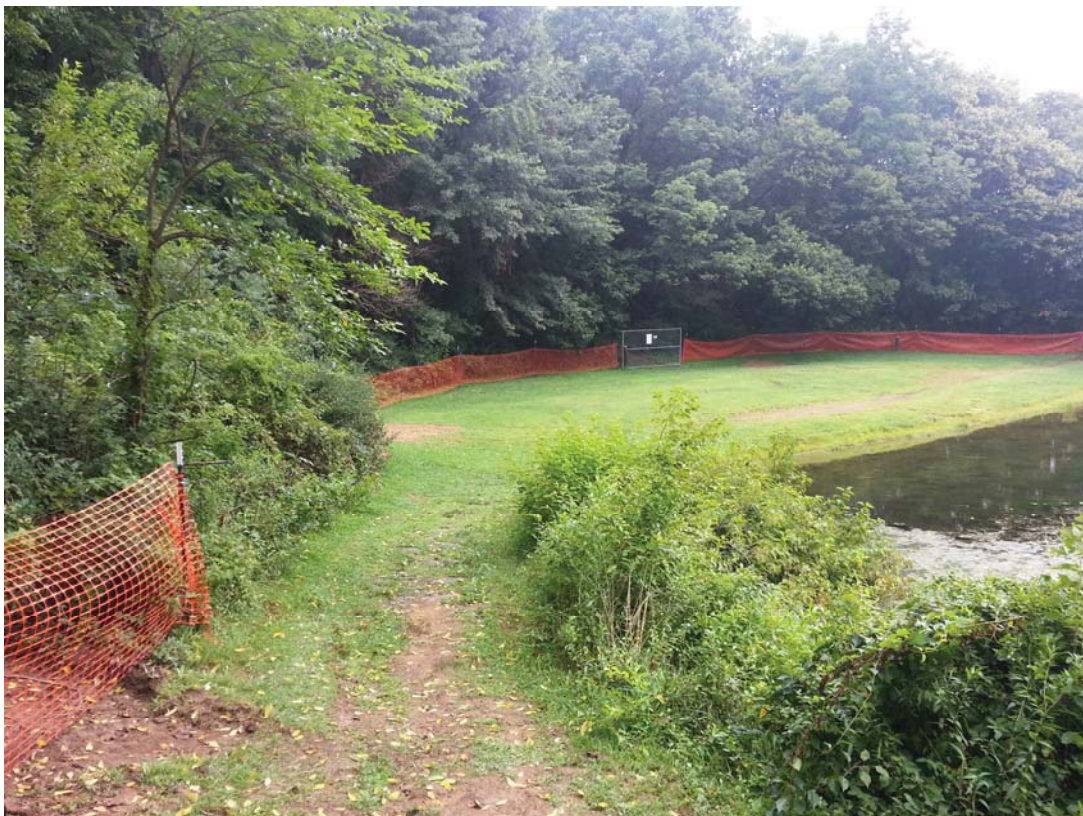
PHOTO 2: View of southern portion of site along dirt trail

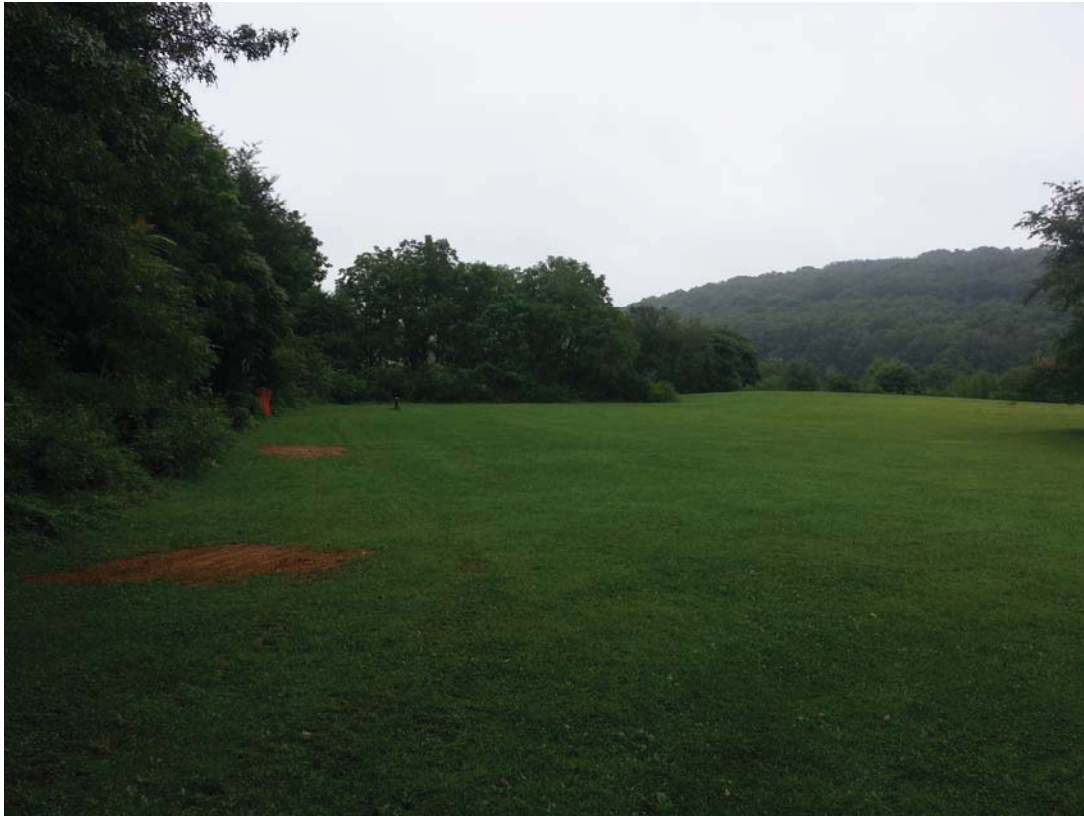
PHOTO 3: View of the northwest portion of the site with completed test pits visible

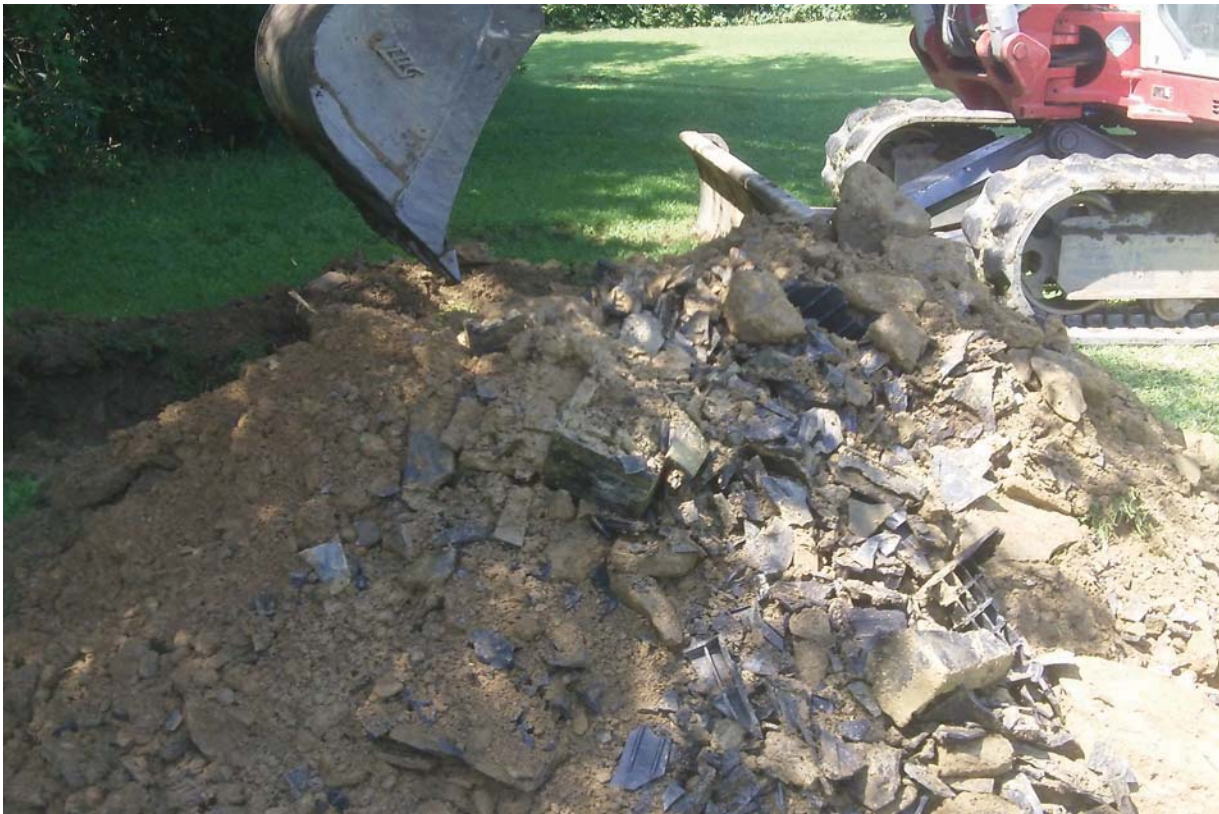
PHOTO 4: View of the soil pile from test pit containing battery casing fragments

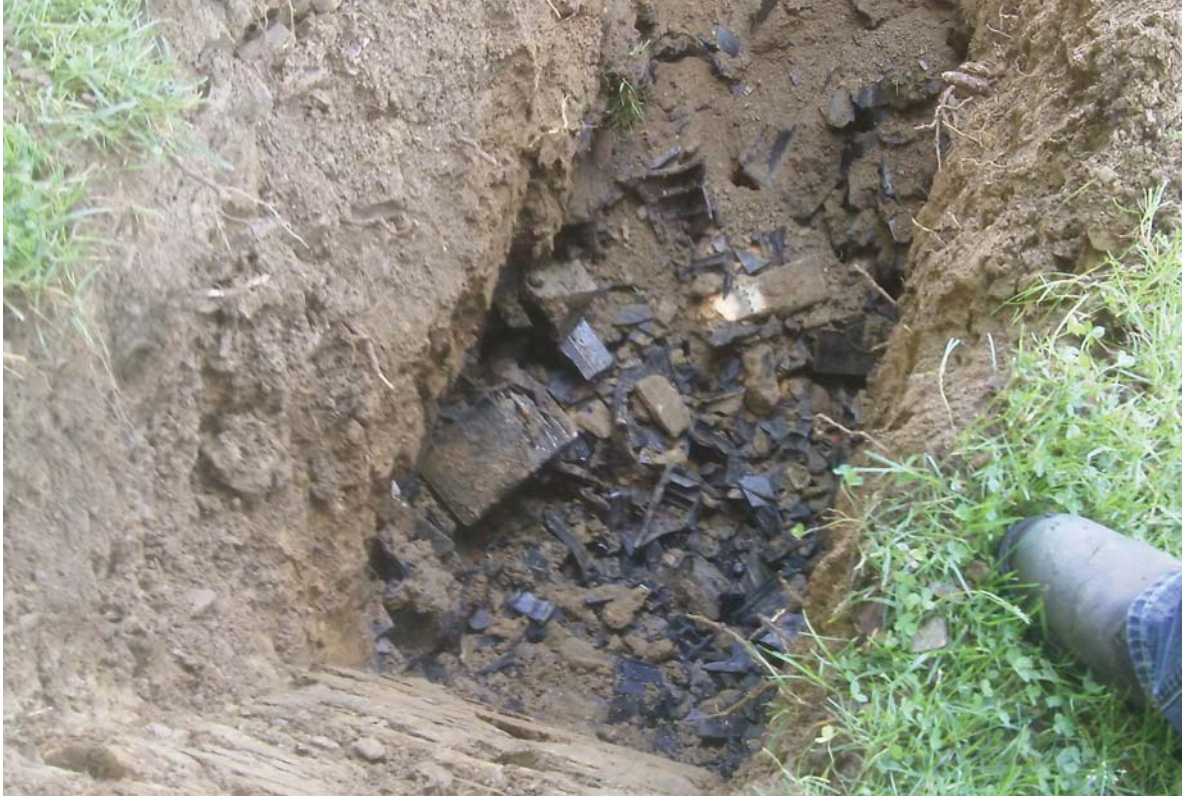
PHOTO 5: View of the interior of a test pit with battery casing fragments

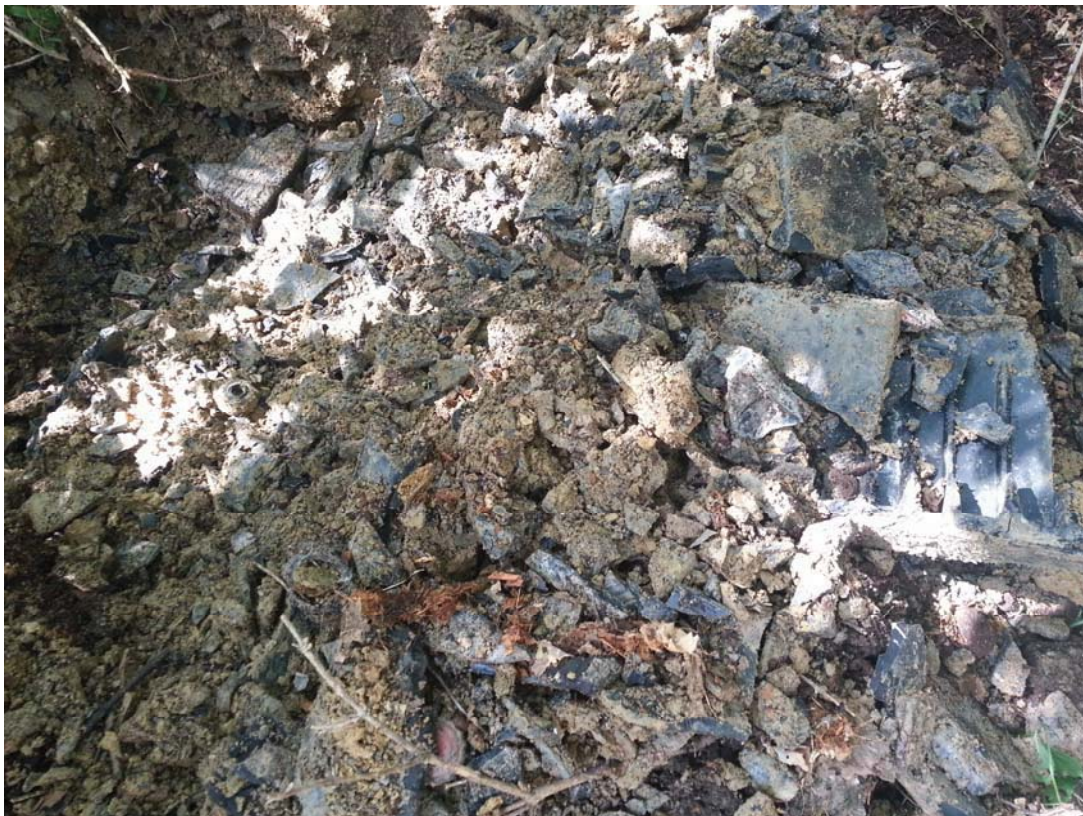
PHOTO 6: View of battery casing fragments in a soil pile
